Salford Catholic Cathedral: High level Repairs and Roof Access

(1 of 2 projects funded)

Salford Catholic Cathedral: North Porch access and drainage (2 of 2 projects funded)

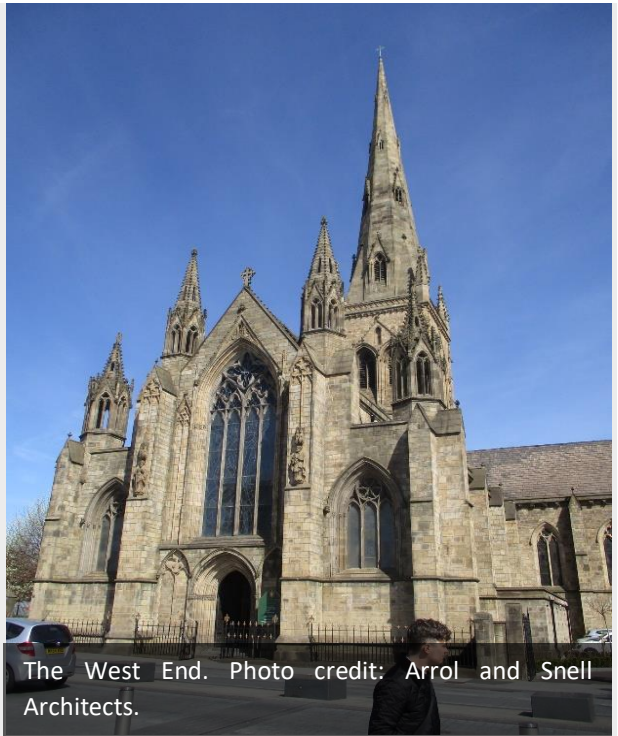
The West End. Photo credit: Arrol and Snell Architects.

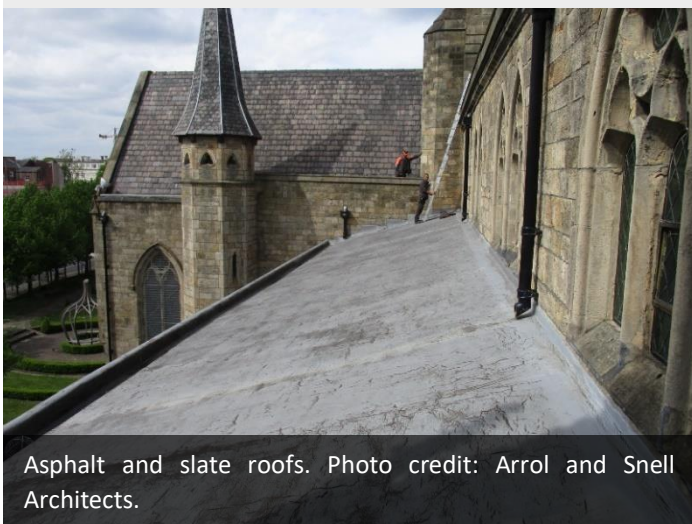
Asphalt and slate roofs. Photo credit: Arrol and Snell Architects.

The work was for significant repairs to the cathedral roofs, parapet gutters, downpipes and drains. Leadwork to flashings and gutters also required replacing.

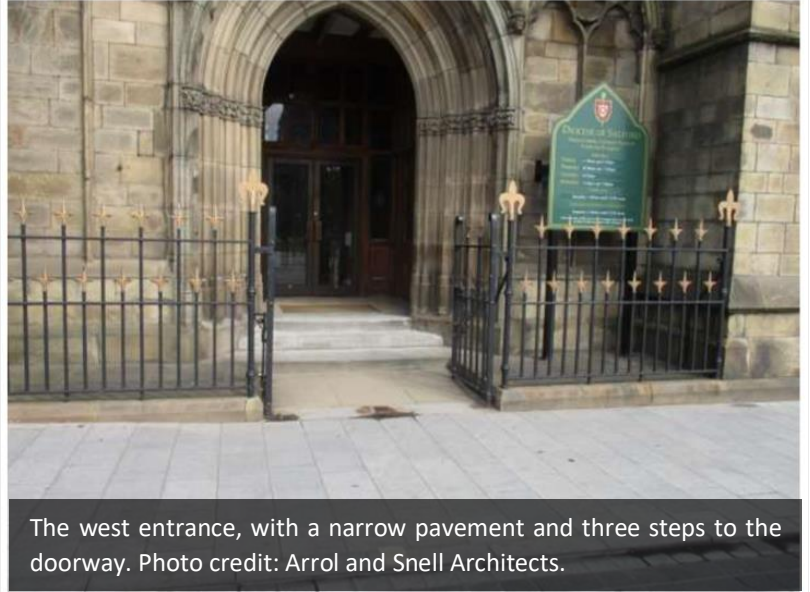
Safe and level access to the cathedral was urgently needed. The main west entrance was inaccessible to wheelchair users as it had three steps, and the recent introduction of level surface treatments to the public road and pavement beyond had reduced the distinction between them, which meant that people leaving the cathedral were walking out directly towards the bus lane. This was considered a real hazard, especially after a major event, and the cathedral was keen to open up the north porch as a new principal entrance. It was barely used, opening onto an unattractive area of modern concrete paving, and its rainwater downpipes discharged directly into the ground, creating damp problems in the surrounding area and the cathedral interior.

The west entrance, with a narrow pavement and three steps to the doorway. Photo credit: Arrol and Snell Architects.

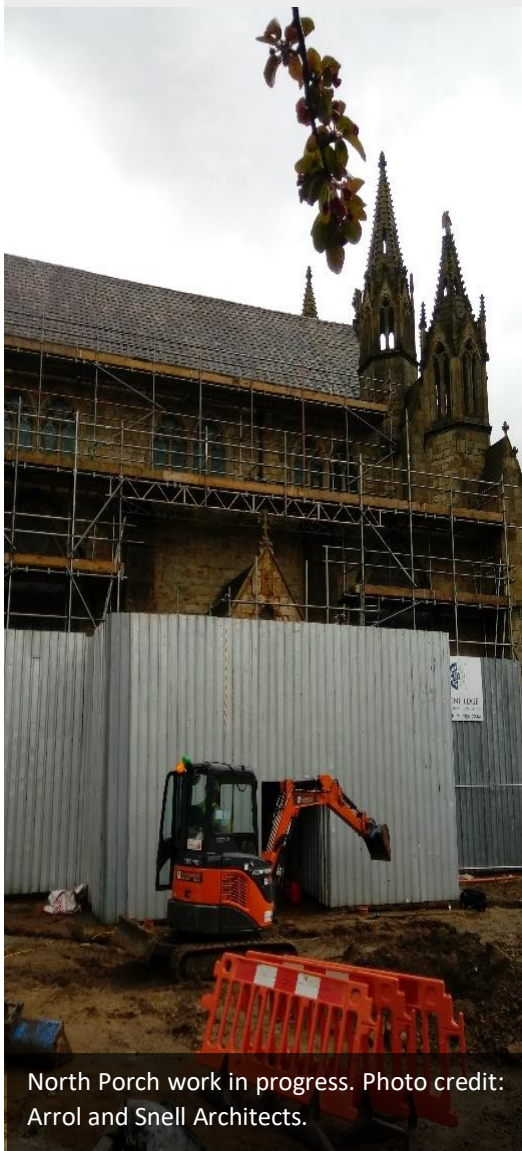
North Porch work in progress. Photo credit: Arrol and Snell Architects.

The North Porch and yard are being made into wheelchair-friendly areas and also providing a main entrance and gathering area which is safe for the public. The drainage defects are being rectified at the same time.
