# Liverpool Metropolitan Catholic Cathedral: Lantern repairs scoping and side entrances repair (1 of 3 projects funded)

# Liverpool Metropolitan Catholic Cathedral: Approaches and main entrance (2 of 3 projects funded)

# Liverpool Metropolitan Catholic Cathedral: Lantern repair research and access (3 of 3 projects funded)

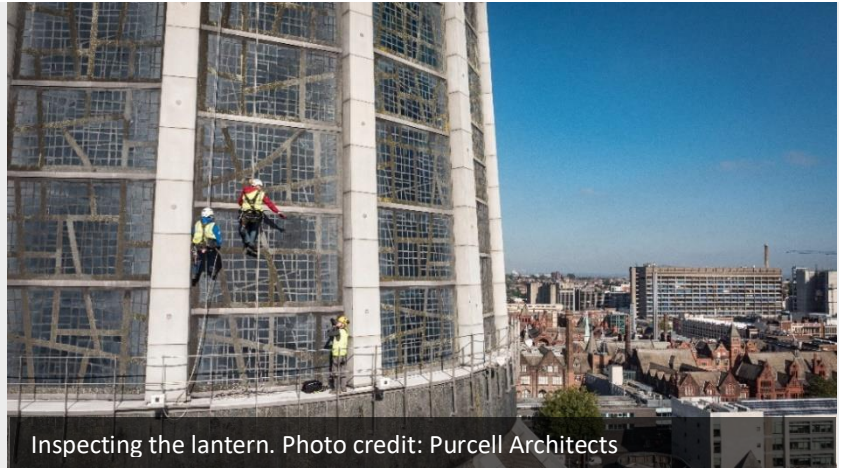
Inspecting the lantern. Photo credit: Purcell Architects

The lantern part of the project consisted of research, investigation and analysis to understand the materials and construction techniques used. The second part involved restoration and repair of the east and west entrance doors, namely fixing defective pivot mechanisms, and associated internal glazed screens, to provide better access to the main cathedral church.

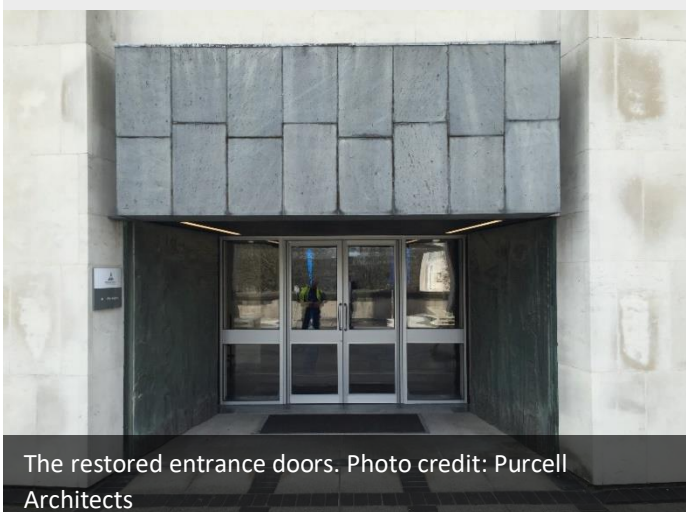
The restored entrance doors. Photo credit: Purcell Architects

The east and west entrance doors, which could not be used previously, even in emergencies, are now operational. This has made the building safer in managing flow in and out of the building, particularly for large events, as well as presenting a more open and welcoming aspect to visitors. The lantern repairs scoping research helped the cathedral with a successful application for £139,000 from the Getty Foundation for further work. The projects have raised the staff's awareness of the importance of their building and how they market it. They have developed greater knowledge of how to assess cathedral works, knowing the right people to get on board, formulating clearer procedures and developing a conservation management plan. The projects have also led to a reevaluation of Liverpool Metropolitan's contribution to post-war architecture, helping it to gain international recognition.

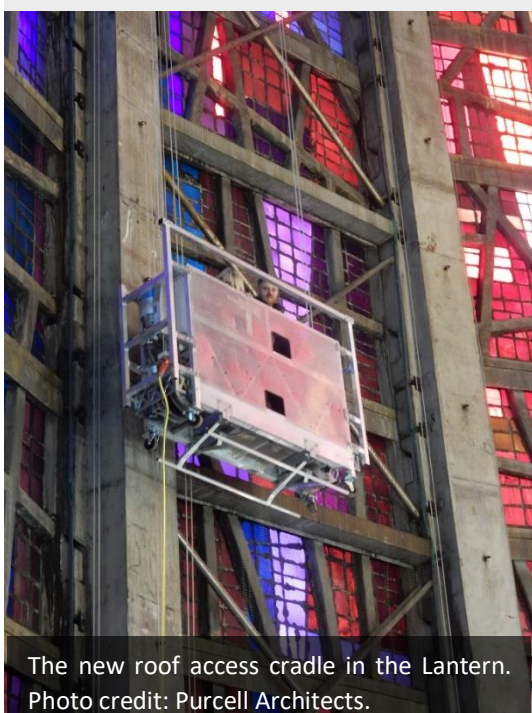
The new roof access cradle in the Lantern. Photo credit: Purcell Architects.

The improved access system makes the lantern a safe space to get to and work in, and will reduce the ongoing costs of inspection and maintenance. The causes of the leaks are now understood. Long-term, the results of this project will support future grant applications to funders such as the Heritage Lottery Fund for repairs and other associated work. There is also an increased understanding of the lantern's architectural significance.

The works built on the initial lantern scoping research (see project summary sheet 1) to establish a long-term repair solution for the Piper and Reyntiens lantern glazing. This project covered monitoring of the water ingress to the lantern, movement monitoring, and experimental methods of water control. It also involved the provision of a safe method for accessing and maintaining the lantern, upgrading the existing access to current safety standards.
