Newcastle Catholic Cathedral: External stonework (project 1 of 1 funded)

Awarded £185,000 in July 2014

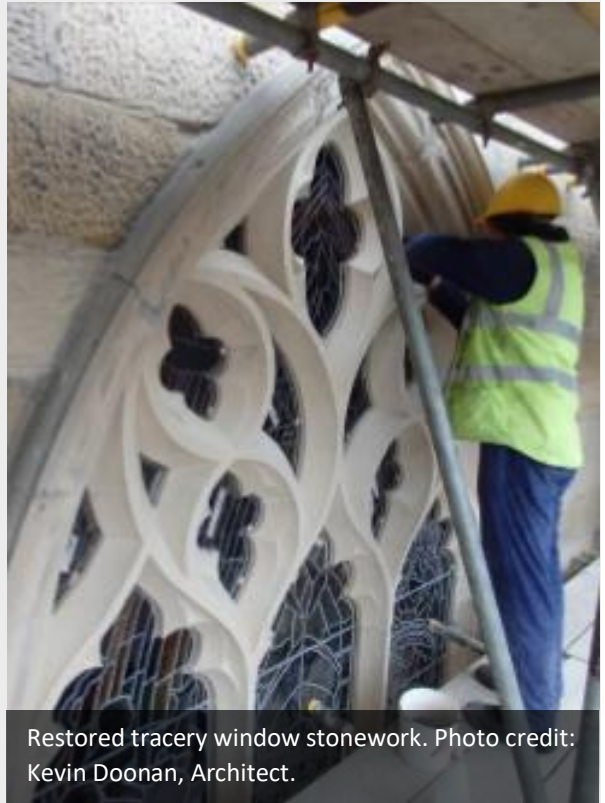
Restored tracery window stonework. Photo credit: Kevin Doonan, Architect.

The stonework repairs to the tracery windows have provided much-needed protection which will prevent further damage and weathering. The repairs to the stained-glass windows and corbel heads have improved the aesthetics of the cathedral.

The works commenced in March 2015 and were complete in December 2015. The works included repairs to tracery and ground-level stonework and repairs of the corbel springing blocks which had become eroded. Additional works included replacing defective hood moulds to the windows and stained-glass work repairs. In accordance with the grant offer, the existing stonework and the work carried out was professional recorded.
