St George, Scarborough

Scarborough, East Yorkshire

Part 1: Core data

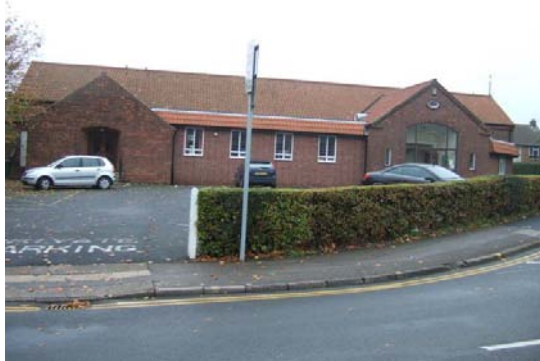
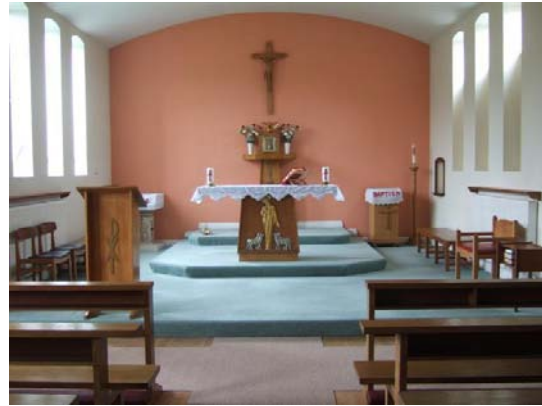
A long rectangular building, red brick with pantiled roof. Church hall at one end, church at the other, divided by a folding screen enabling the two to be thrown together. The appearance of the building is more that of a church hall or community centre than an ecclesiastical building, i.e. domestic-style windows, doors and proportions. The original windows are of Crittall type with square leaded glazing. 1980s addition along the entrance side of the building, comprising a lean-to kitchen and other service facilities and gabled entrance bays, the church entrance with a larger segmental arch and glazed screen.
